CITY OF POMONA • PUBLIC WORKS DEPARTMENT
ENVIRONMENTAL SERVICES DIVISION
Storm Water Facility Inspection/Site Visit Report Form

Facility Name: TRIANGLE FURNITURE

Site Address: 1810 S RESERVOIR ST

Stormwater Inspection
1810 S Reservoir St
Pomona, California
21AUG08

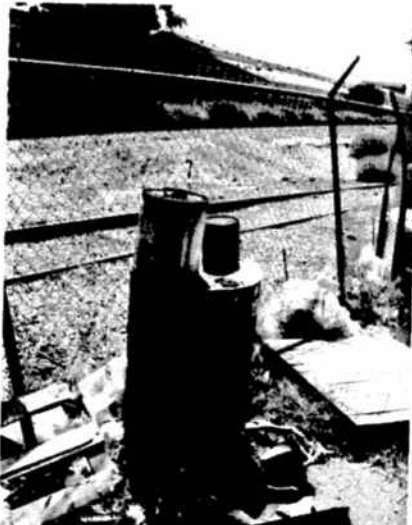
PHOTOGRAPH 1.

View of a oily bucket on top of a 55-gal drum the E side of the facility.

The tenant was instructed to remove or cover the bucket and drum.

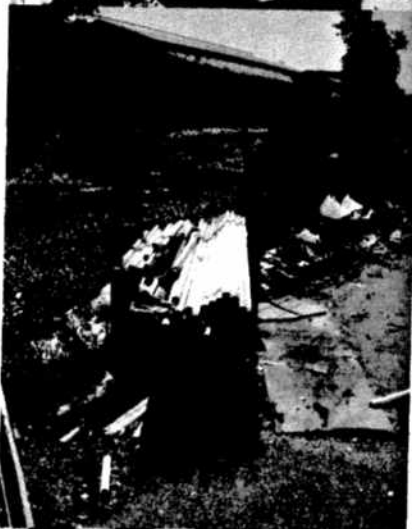
PHOTOGRAPH 2.

View of fluorescent light bulbs located on the E side of facility.

The tenant was instructed to remove or cover the bulbs.

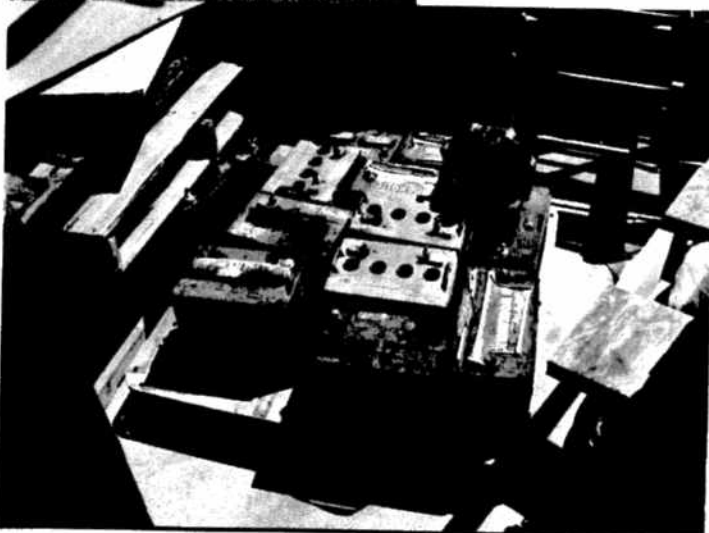
PHOTOGRAPH 3.

View of old car batteries on the E side of facility.

The tenant was instructed to remove or cover the car batteries.

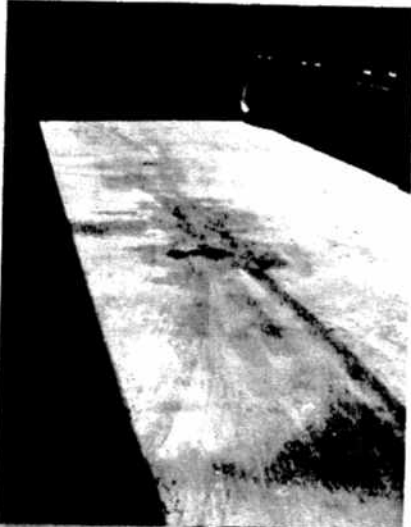
PHOTOGRAPH 4.

J. FACILITY GROUNDS HAD SOME
AREAS THAT NEEDED TO BE CLEANED.
- OIL STAINS BY SW LOADING DOCK
NEEDS TO BE CLEANED UP USING
A DRY ABSORBENT MATERIAL

View of oil staining from trucks located by the loading bays on the SE side of facility.

The tenant was instructed to place absorbent material on the stains and sweep up the material. Also, the tenant was instructed to have a spill kit easily accessible and available.

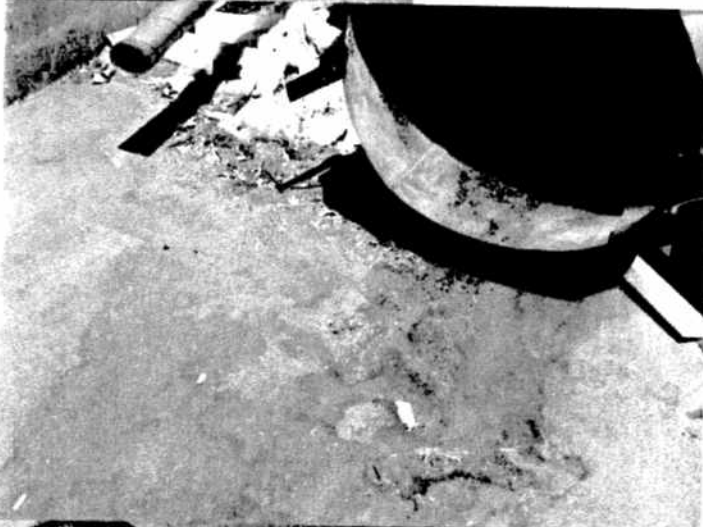
PHOTOGRAPH 5.

F. OPERATIONS OUTSIDE - OBSERVED
SAWDUST / WOOD DEBRIS, SHOULD
BE CLEANED - UP MORE REGULARLY

View of sawdust and trash debris on the E side of facility.

The tenant was instructed to sweep up trash and debris on a more regular basis.

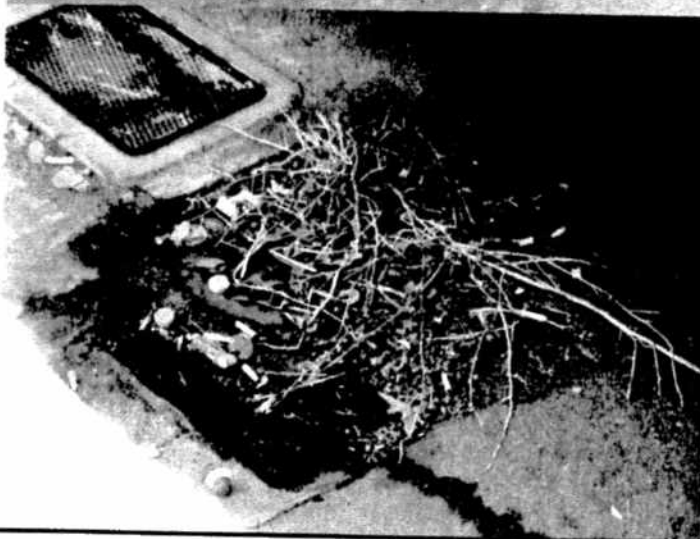
PHOTOGRAPH 6.

- STORM DRAIN IN NW PART OF
PARKING LOT HAD A BUILD-UP
OF DEBRIS.

View of debris built up around storm drain on the NW side of facility.

The tenant was instructed to sweep up trash and debris on a more regular basis and keep drains clear.

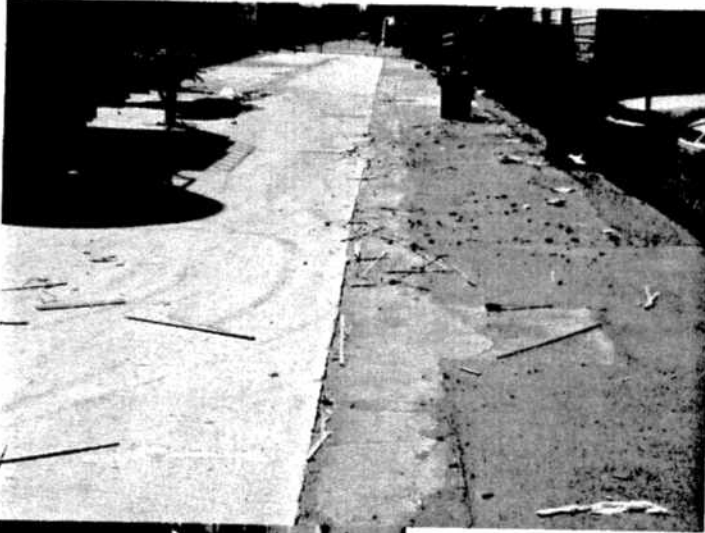
PHOTOGRAPH 7.
View of debris along the SW
side of facility.

The tenant was instructed to
sweep up trash and debris on a
more regular basis.

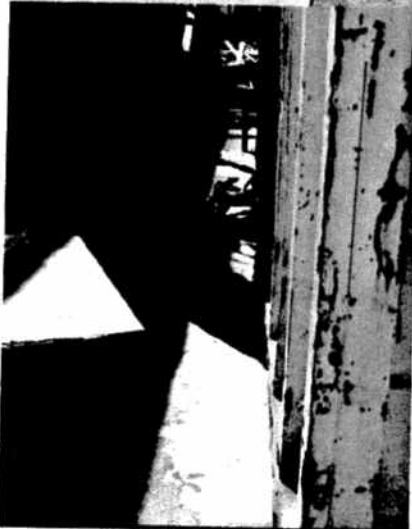
E. AREA UNDER HOPPER SHOULD BE
CLEANED MORE REGULARLY. BUILD
UP OFF SAW DUST / WOOD DEBRIS
LOCATED IN AREA UNDER HOPPER
* AROUND DUMPSTER

PHOTOGRAPH 8.
View of debris from the hopper
on the SW side of facility.

The tenant was instructed to
sweep up debris on a more
regular basis.
